AIRCRAFT ACCIDENT REPORT AND EXECUTIVE SUMMARY

Reference:	CA18/2/3/8959	
Aircraft Registrations	ZS-NJX AND ZU-MMI	Date of Accident	14 August 2011		Time of Accident	±0830Z
Type of Aircrafts	Piaggio P166 Albatrosses		Type of Operation	Private		
Pilot-in-command Licence Types		Commercial and Private	Ages	61 and 57	Licences Valid	Yes
Pilot-in-command Flying Experience		Total Flying Hours	Approximately 4286 and 2893 respectively		Hours on Type	Unknown
Last point of departure		Tzaneen Aerodrome (FATZ) - Limpopo				
Next point of intended landing		Rand Airport (FAGM) - Gauteng				
Location of the accident site with reference to easily defined geographical points (GPS readings if possible)						
On a mountain, approx 500m south-east of Tzaneen, – GPS positions: S24°05,107', E030°11,230' and S24°05,107', E030°11,185; Elev = 5030 ft AMSL						
Meteorological Information		Wind: 160°03 knots ; Temperature: 14 °C;				
Number of people on board	1+5; and 1+6	No. of people injured	0	No. of people killed	13

AIRCRAFTS ACCIDENT REPORT

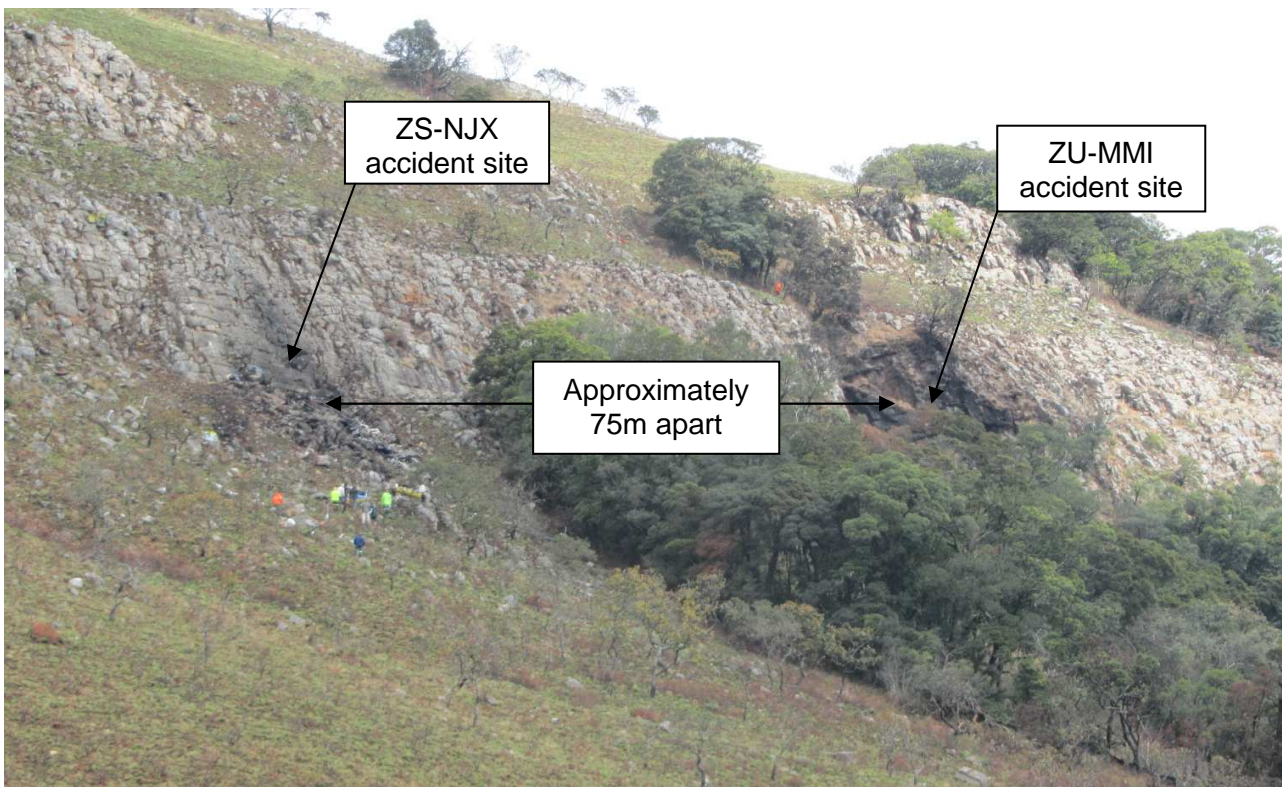
Photo 1: Showing the accident sites of the two aircrafts.

- 1.1.7. A witness staying in the Lekgalametse Valley area stated that he saw both aircraft momentarily flying over the valley before they disappeared into the thick, low clouds which were covering the valley. He also stated that he heard a loud bang moments after he saw the aircraft flying overhead him.
- 1.1.8. Both aircraft were destroyed by fire and all the occupants of both aircraft were fatally injured.

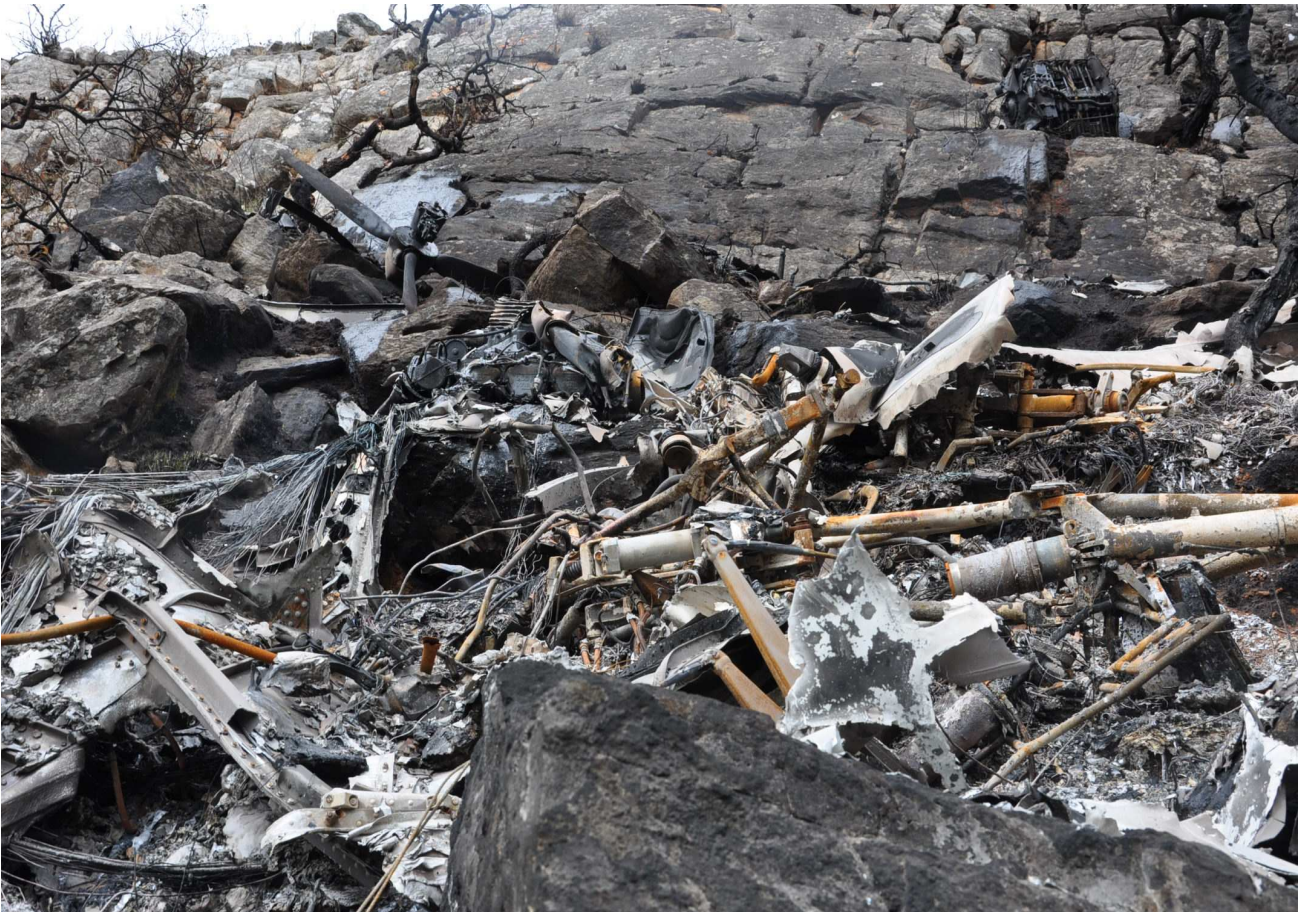
1.3.1. Both aircraft were destroyed during the accident sequence.

Photo 2: Showing damage to ZS-NJX

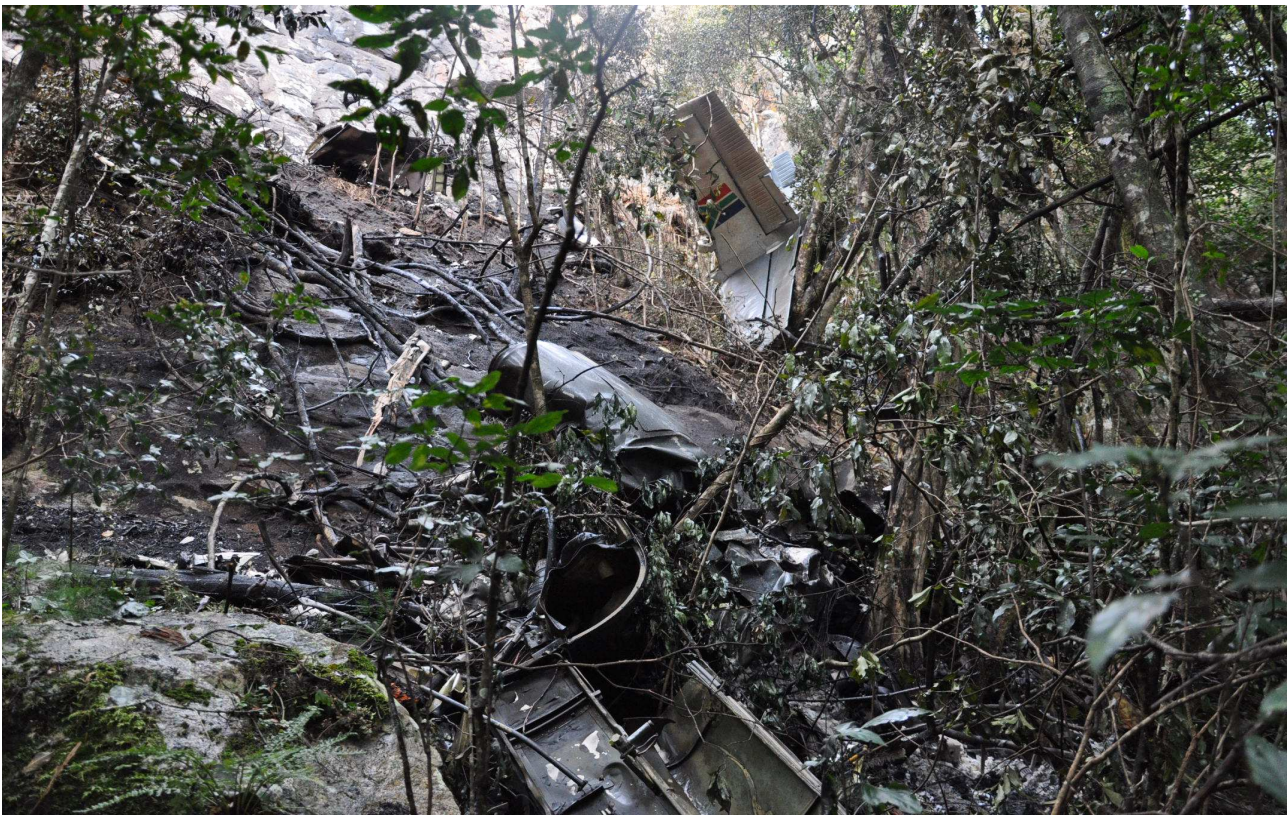
Photo 3: Showing damage to ZU-MMI

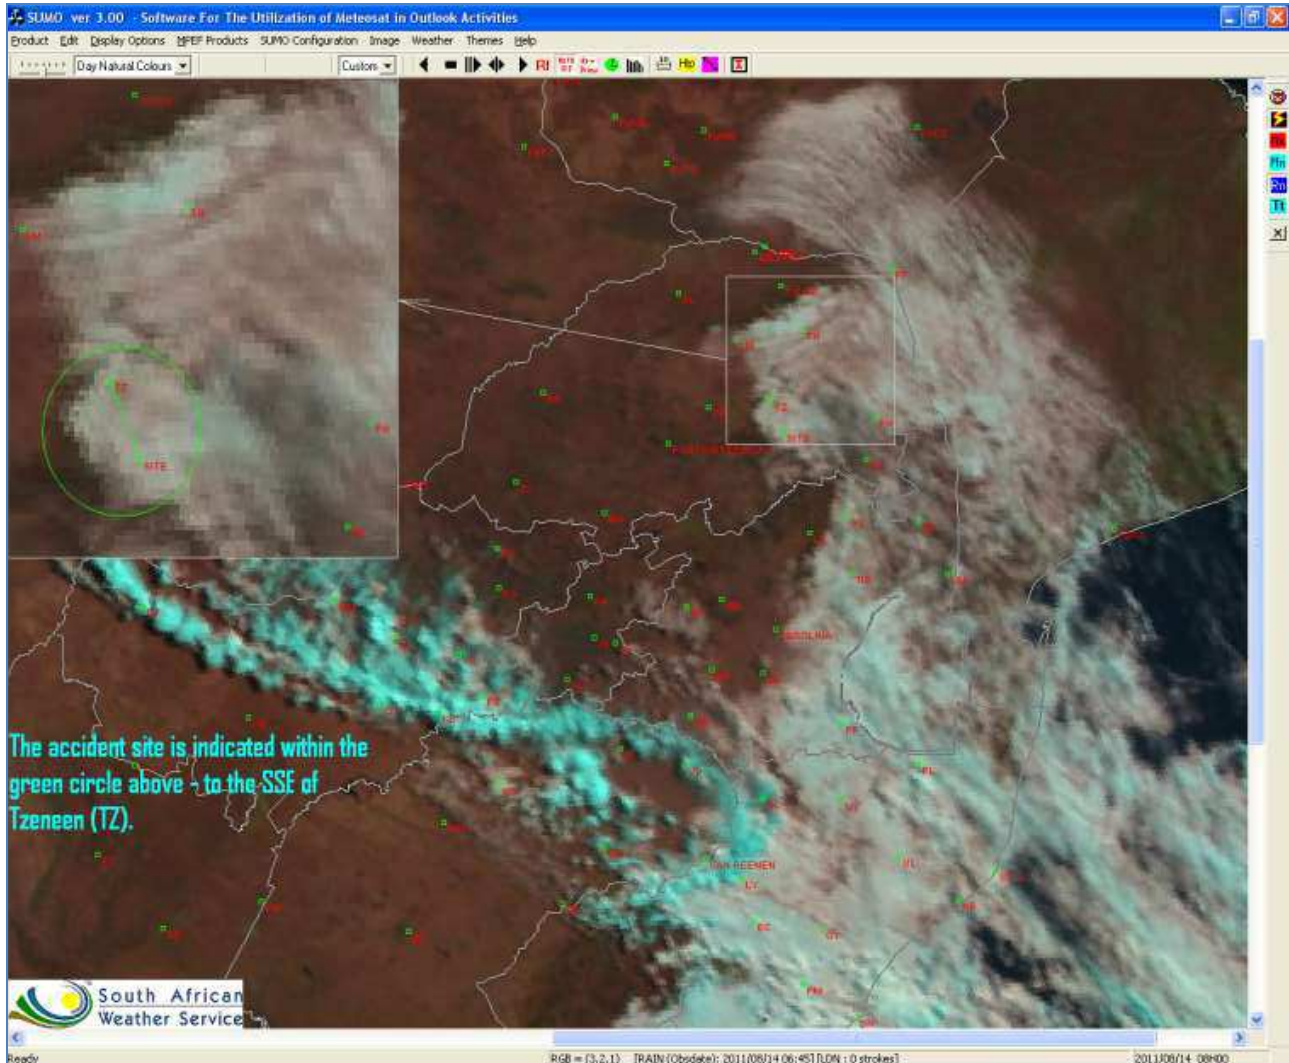
1.7.2. SATELLITE IMAGE (0800Z 14 AUGUST 2011)

The satellite image below shows a uniform layer (overcast) of low level clouds (stratiform) over the eastern and north-eastern parts of the country, which extend from the coast up to the escarpment areas. The brown colour indicates the ground (earth surface) while the light (whitish/creamy) shades depict low clouds. Mid-level clouds over the central interior are indicated by the light-blue colour within which convective cells can be identified as the cellular structures within this mid-level cloud band.

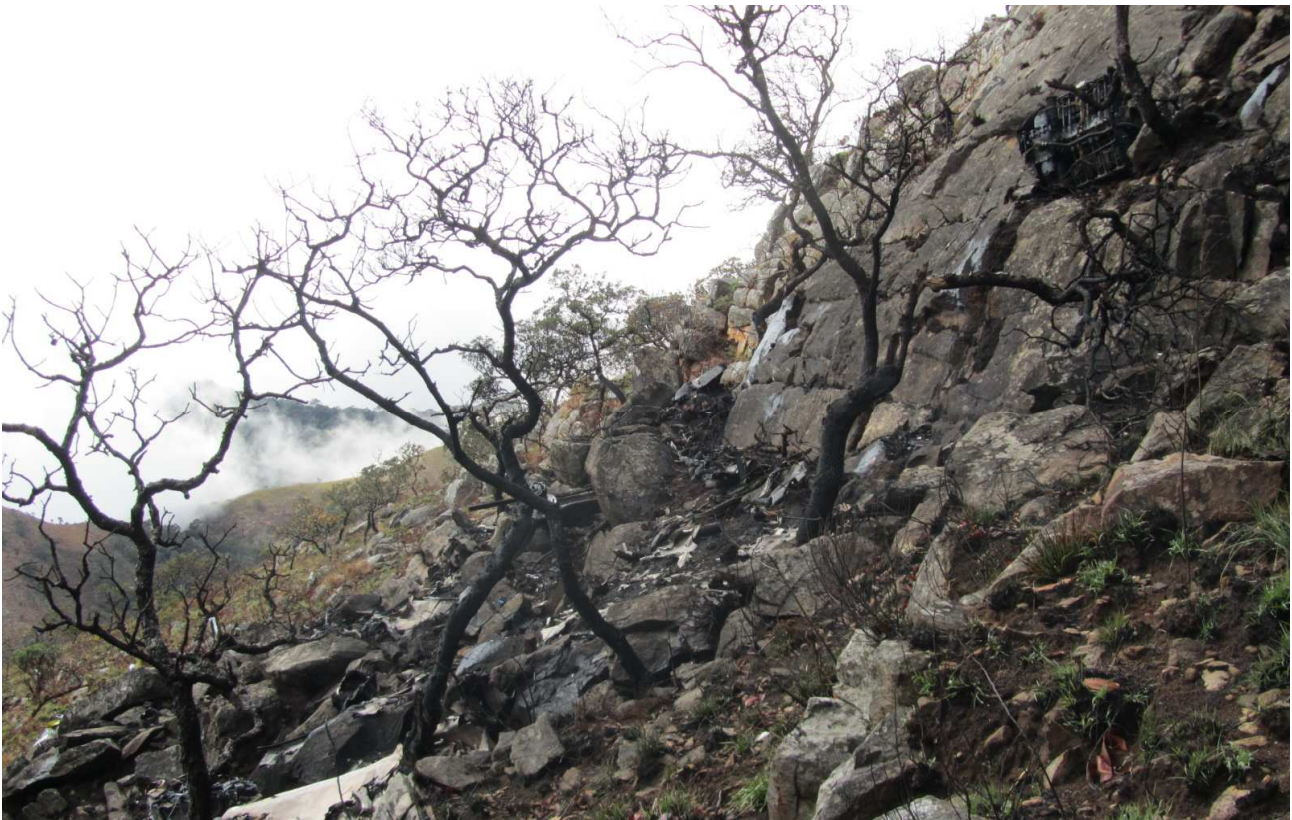
1.12.2.1. The terrain where the aircraft was found was a steep slope of approximately 60 degrees, with a lot of outcropped rocks and several trees and bushes in the vicinity, but no pre-impact skid or scratch marks were observed on any of the trees, bushes or rocks in the vicinity of the wreckage site.

1.12.2.2. The aircraft's point of impact with the mountain was at a rocky wall with an approximate 90 degree slope, approximately 20 meters below the top of the mountain, before sliding down the mountain a further 10 to 15 meters.

Photo 4: Showing the slope, terrain and impact point of ZS-NJX

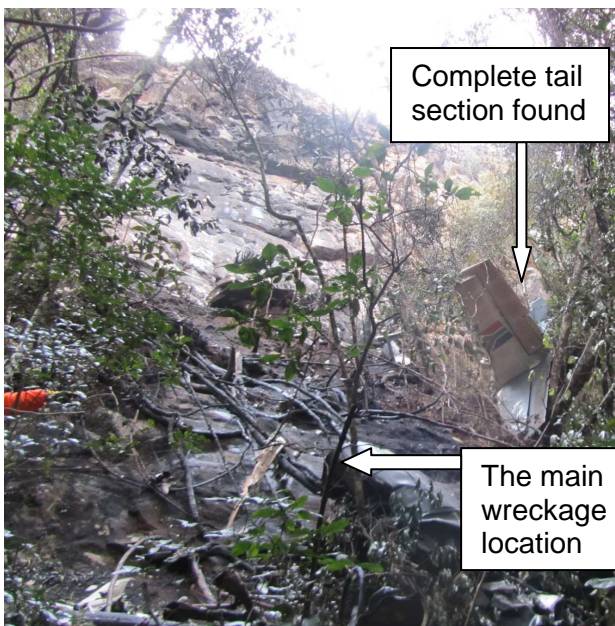
1.12.2.3.A post impact fire ensued which destroyed most of the aircraft structure. The tail section was found in a relatively complete condition close to the main wreckage, with one of the engines found approximately a further 30 meters from wreckage down the slope, in between the trees.

Complete tail section found

The main wreckage location

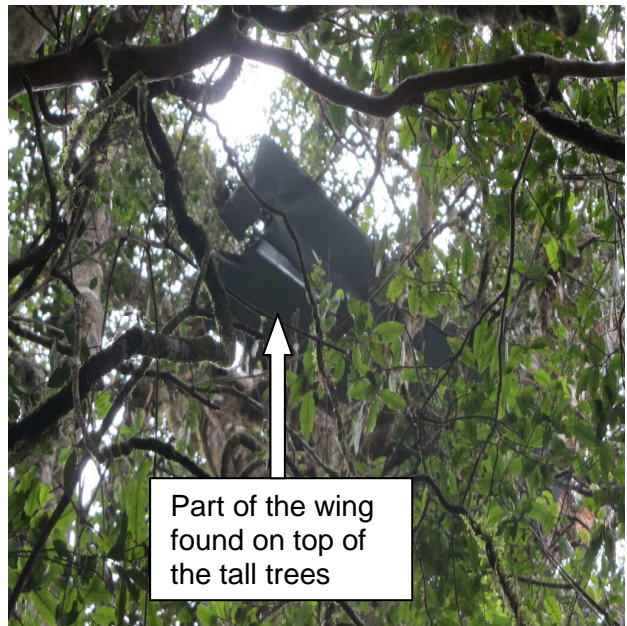
1.12.3.1. The terrain where the aircraft was found was a steep, wet and slippery slope of approximately 80 degrees, with a lot of huge, outcropped rocks, and a lot of tall trees. A lot of pre-impact marks were observed on top of the tall trees, and part of the left wing structure was found stuck on top of the tall trees.

Part of the wing found on top of the tall trees

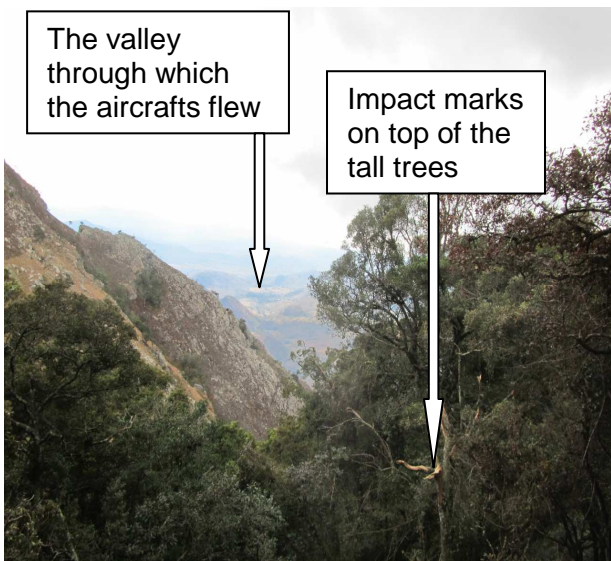
The valley through which the aircrafts flew

Impact marks on top of the tall trees

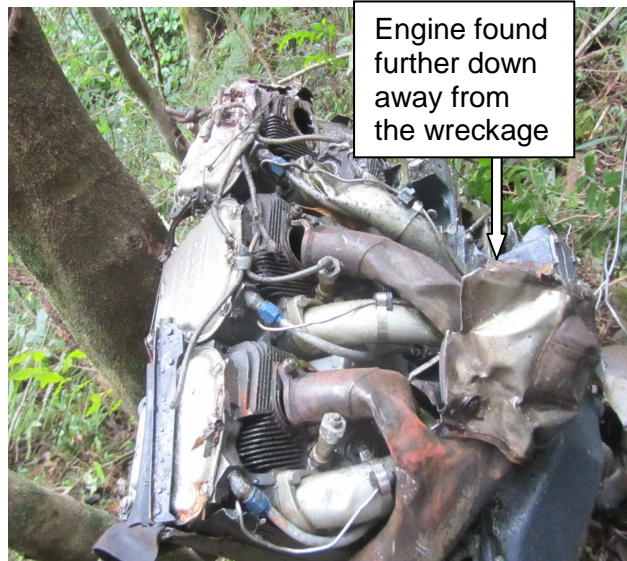
Engine found further down away from the wreckage

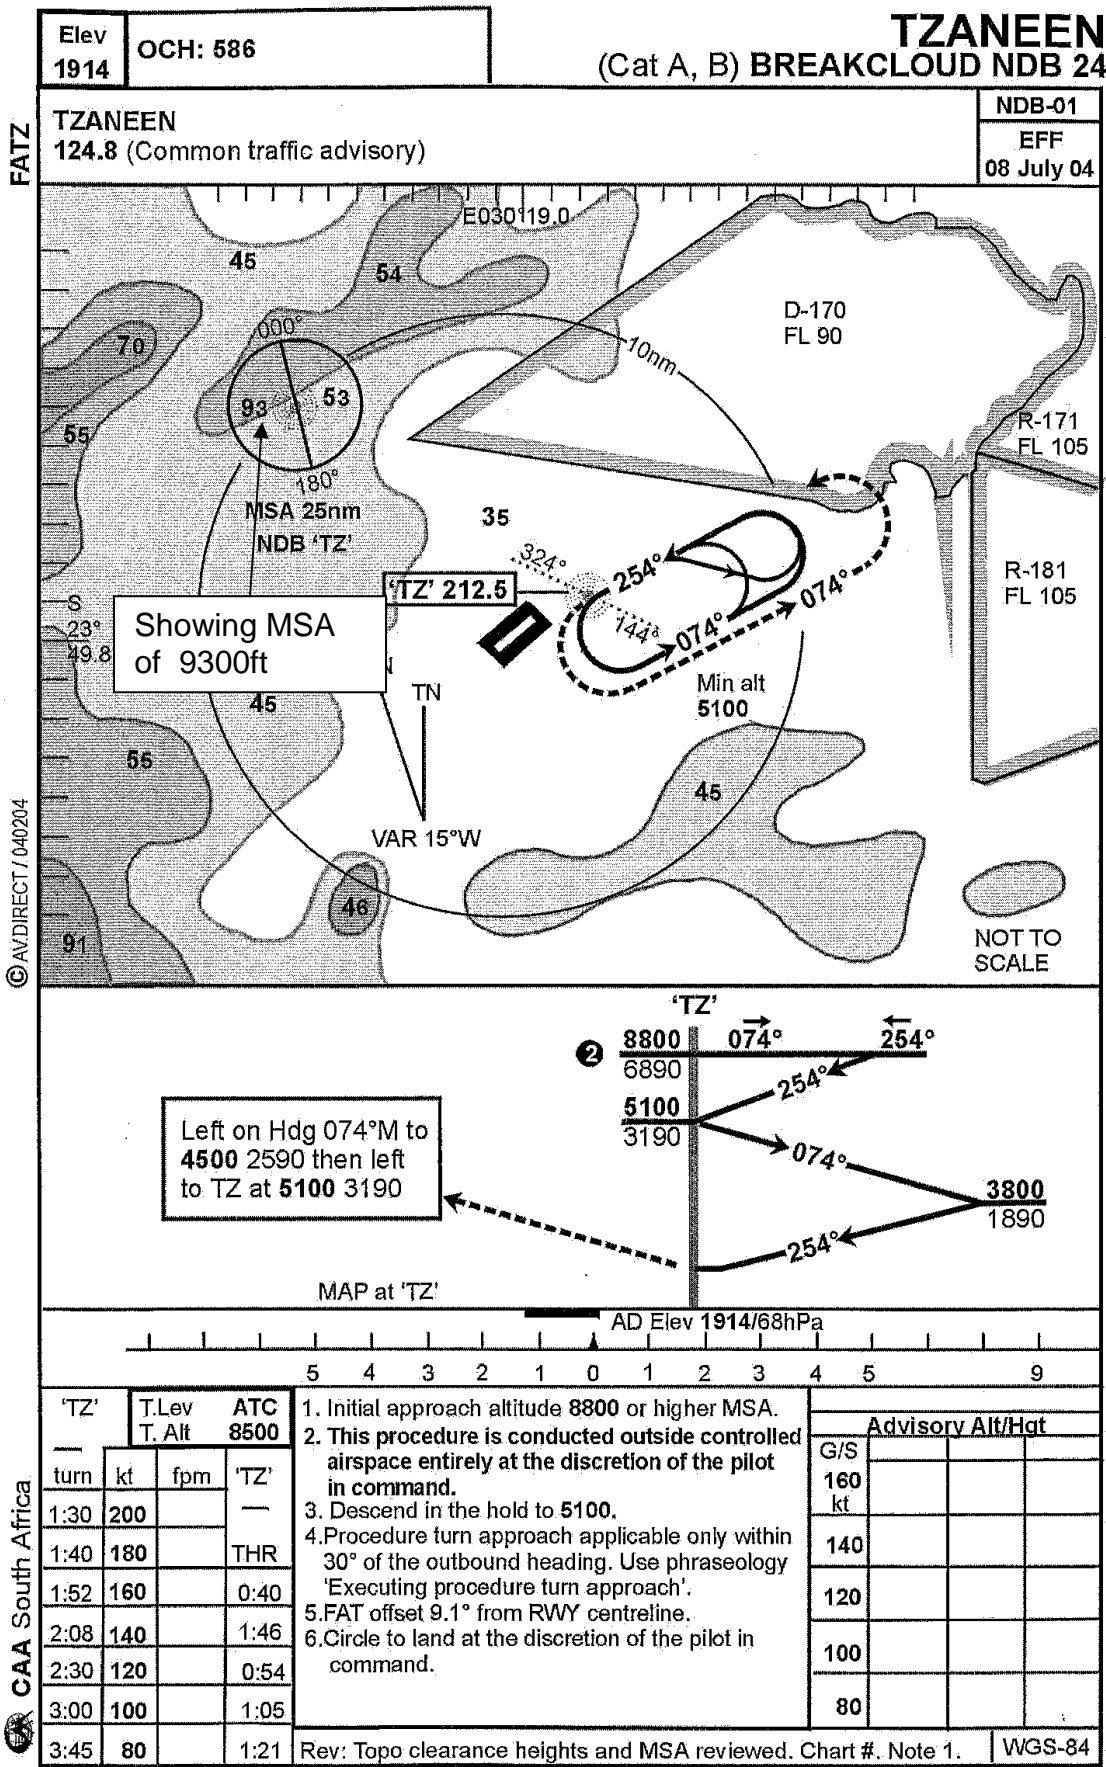
AIP COPY SHOWING MSA

- 1.18.5. The minimum sector altitude (MSA) for the sector in which these aircraft were flying is 9300ft, and these aircraft collided with a mountain at 5030 ft AMSL. See **Appendix 1** – a copy of an aeronautical information publication (AIP) leaflet, as published by SACAA, taken as it was at the time of the accident.
